Gunn Memorial Library

Washington, CT

Thermographic Inspection Images

This report contains selected infra-red images taken during a thermographic inspection and blower door test conducted at the Gunn Memorial Library on May 4, 2011.

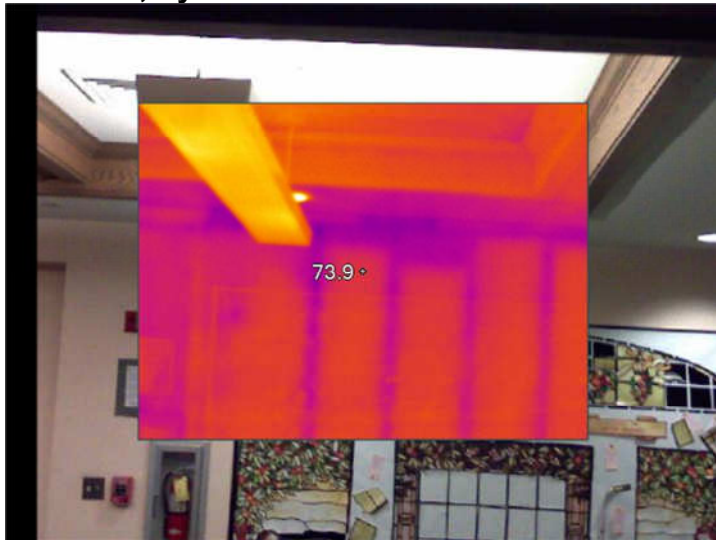
2nd floor, by main entrance

Missing or settled insulation at the top of wall cavities

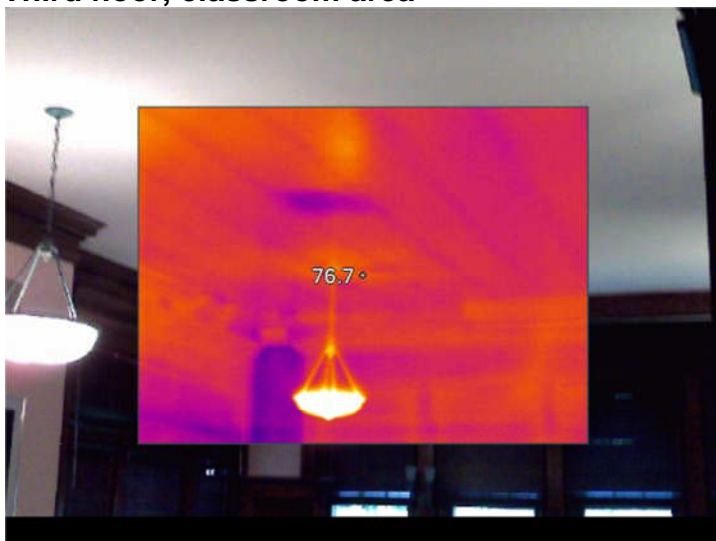
Third floor, classroom area

Section of missing insulation in ceiling. A similar area was also seen on the other side of the room

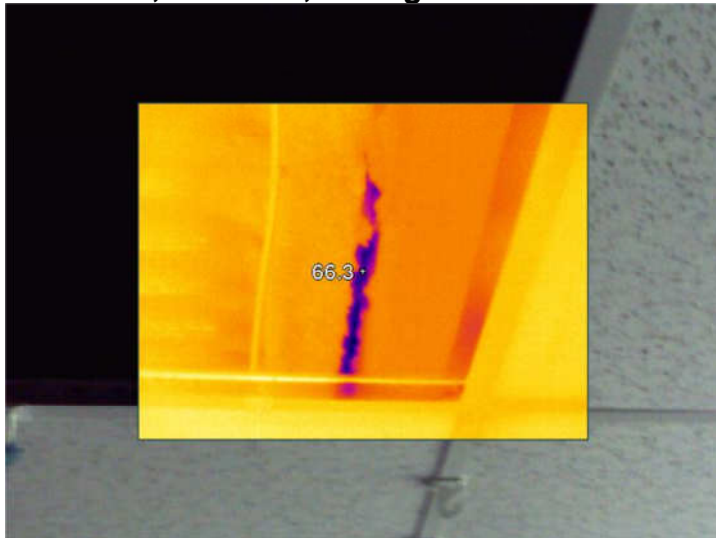
First floor, NE room, ceiling area

Ceiling tiles had been removed, probably to find source of water stains on ceiling tile. A section is apparent where you can see up to the underside of the small roof area above with no insulation.

The same defect is probably found under the small roof section in the SE of the 1st floor

Filling gap with spray foam should reduce cold air from roof cavity chilling the ceiling.

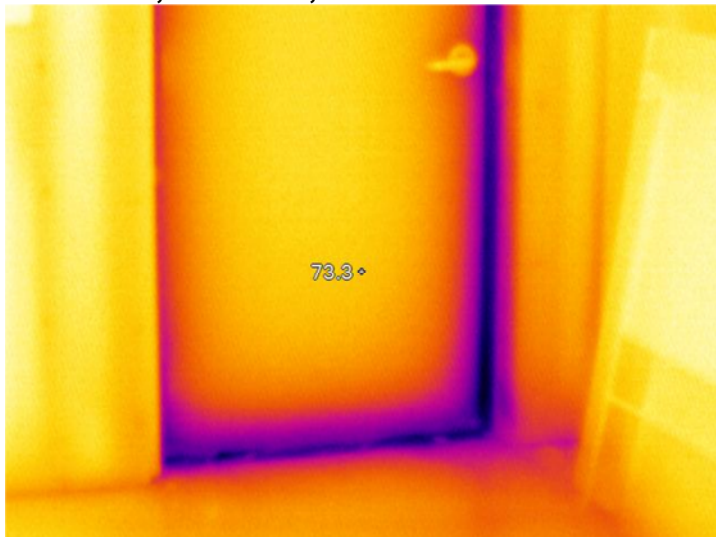
Basement, exit door, S side

Infiltration around doors. Weather-stripping should be checked and adjusted or replaced

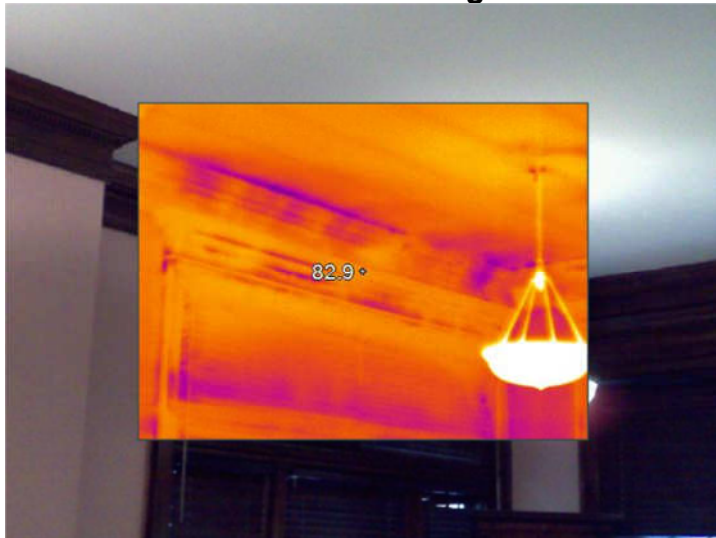
3rd Floor classroom area ceiling

Air infiltration can be seen most noticeably along the top edge of the crown molding and also at other joints.

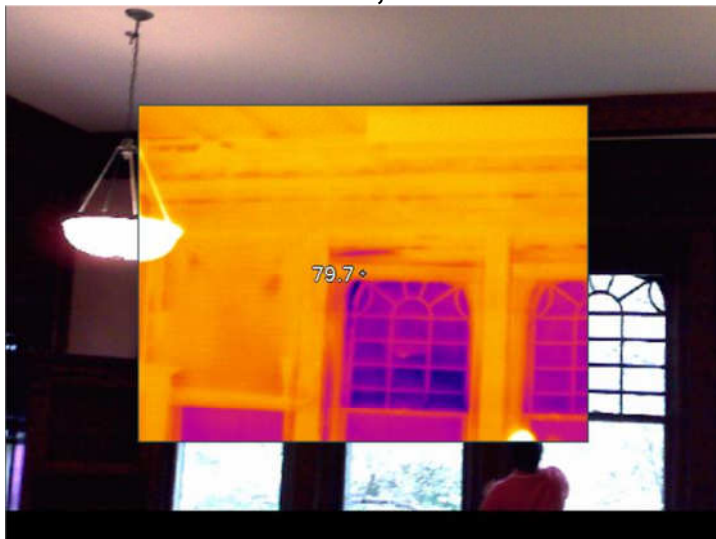
3rd floor classroom area, N wall

Air infiltration around the tops of the windows.
New storm windows are being installed and will reduce infiltration around windows

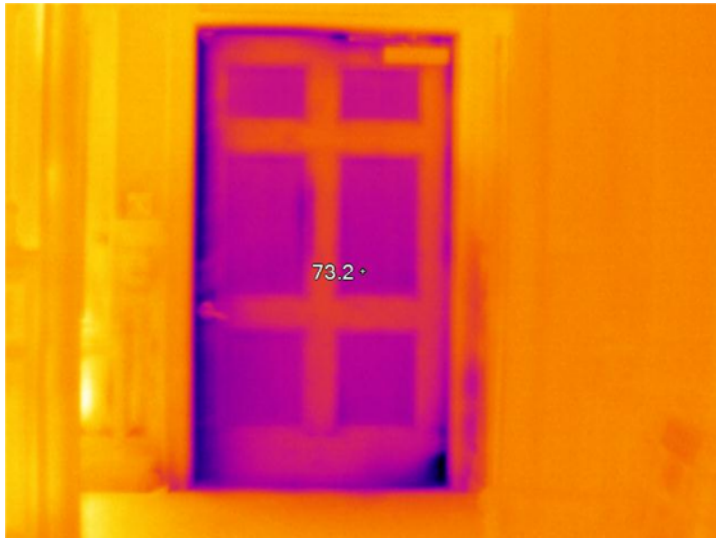
3rd floor exterior door

Air infiltration around edge of door. Daylight can be seen through gaps at several places.

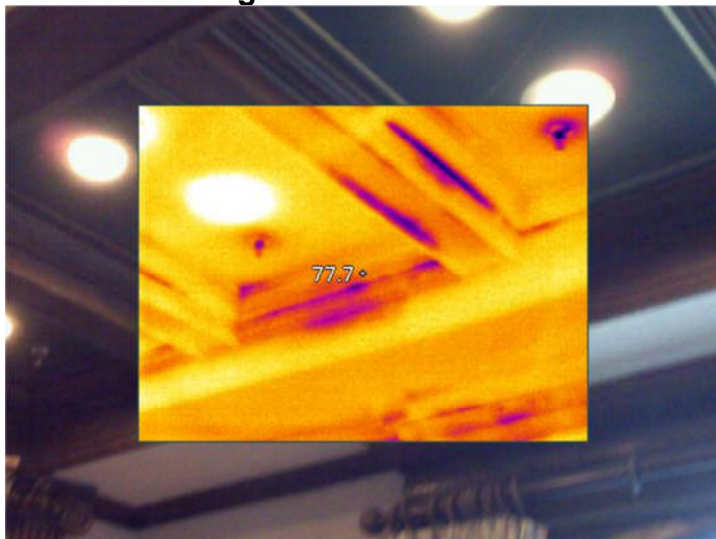
3rd floor reading room

Air infiltration around coffering on ceiling

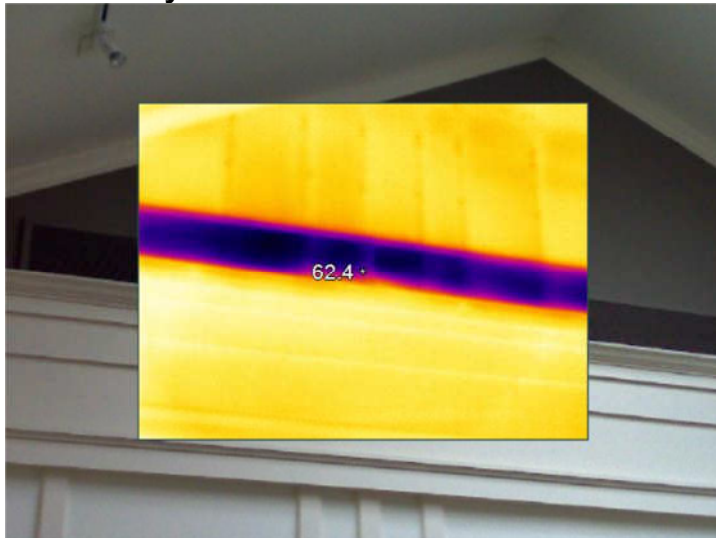
Main library atrium

Major air infiltration through return side of HVAC system. This could be due to leaky ductwork but is more likely due to fresh air inlet dampers either being open or being very leaky. Replacement with mechanically controlled dampers would then reduce this problem.

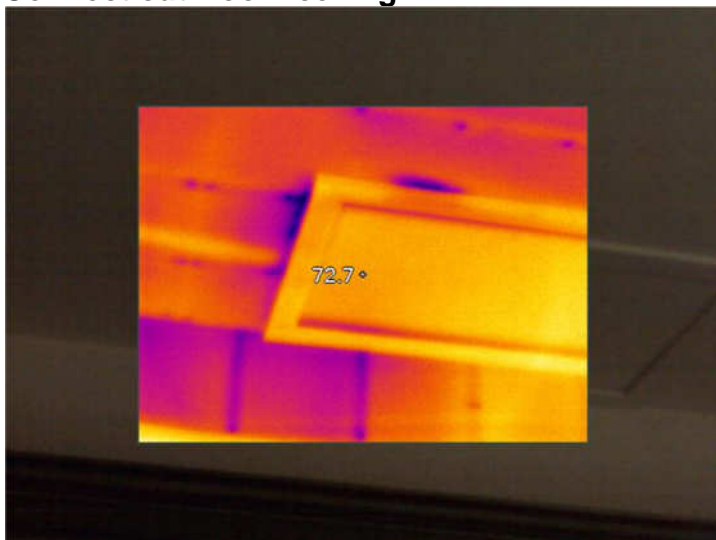
Connecticut Room ceiling

Air leakage through gap between ceiling and hatch trim

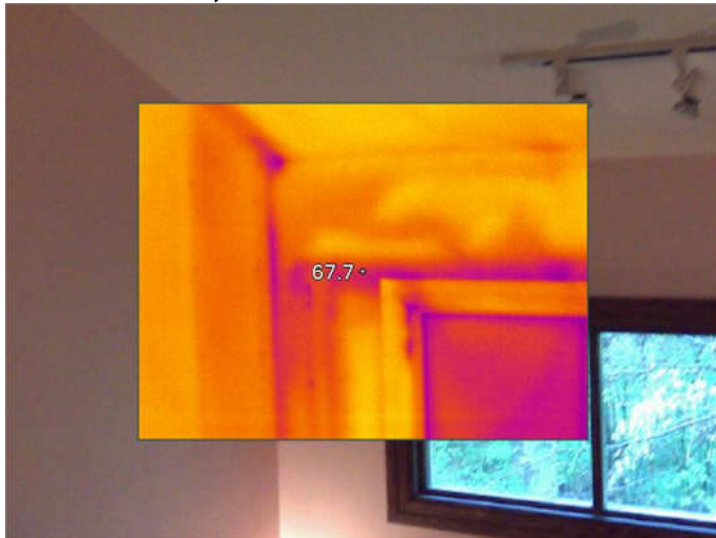
Main stairwell, 3rd floor

Poorly installed insulation allows air movement inside walls

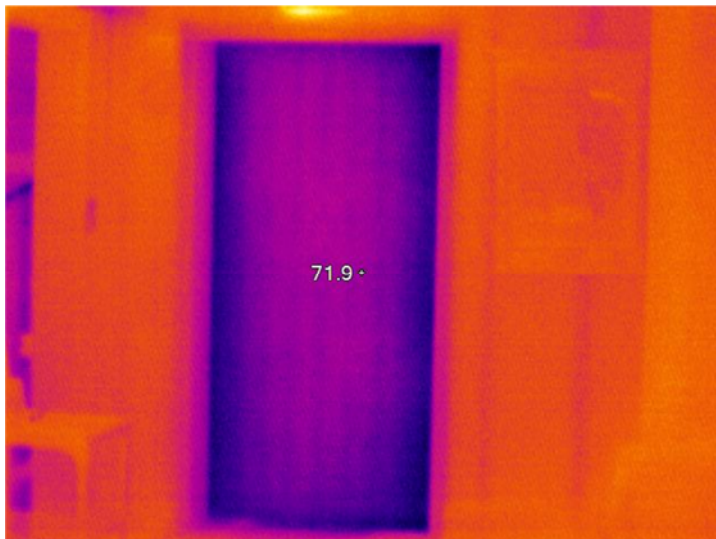
2nd floor elevator door

Significant air leakage is coming from elevator shaft

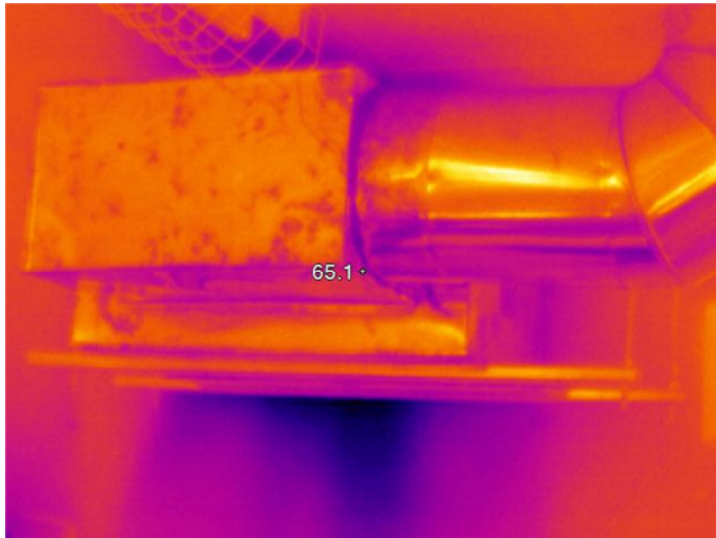
Second floor electrical room

Air leakage around fresh air inlet for HVAC system

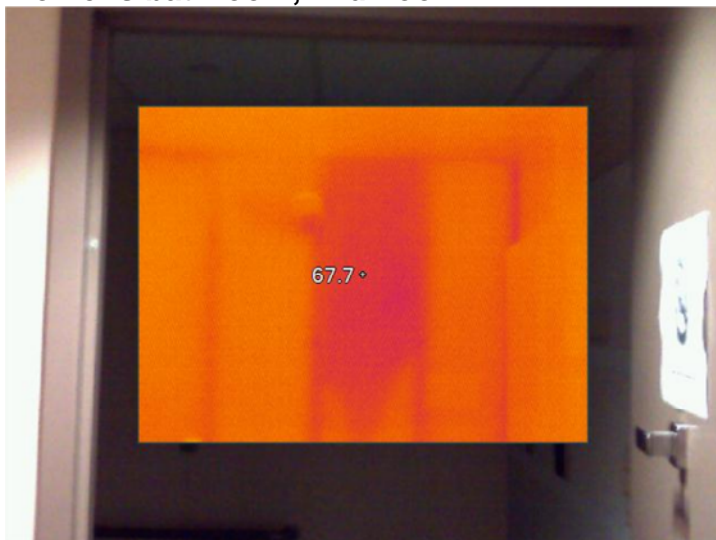
Womens bathroom, 2nd floor

Poorly installed insulation in one wall cavity

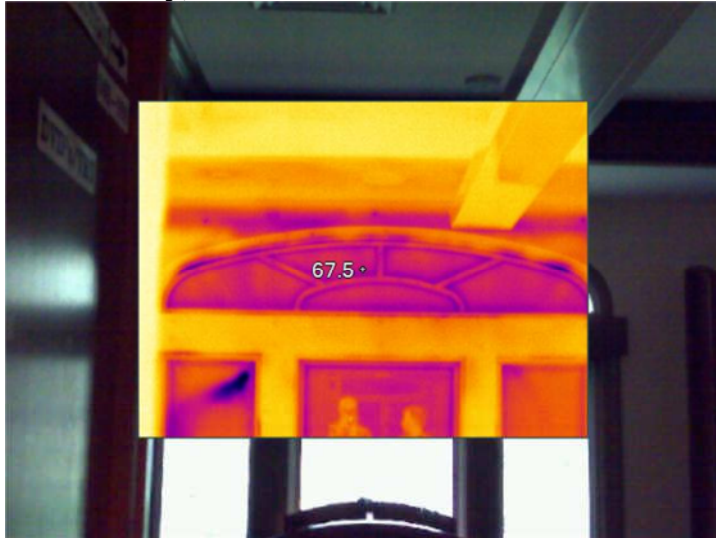
Main library, N wall

Missing insulation in cavities above windows

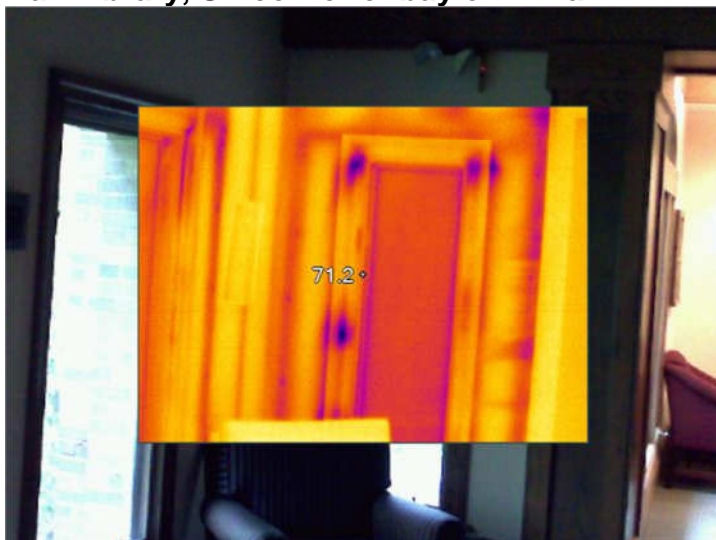
Main library, SE corner of bay on E wall

Shows typical air infiltration around window trim

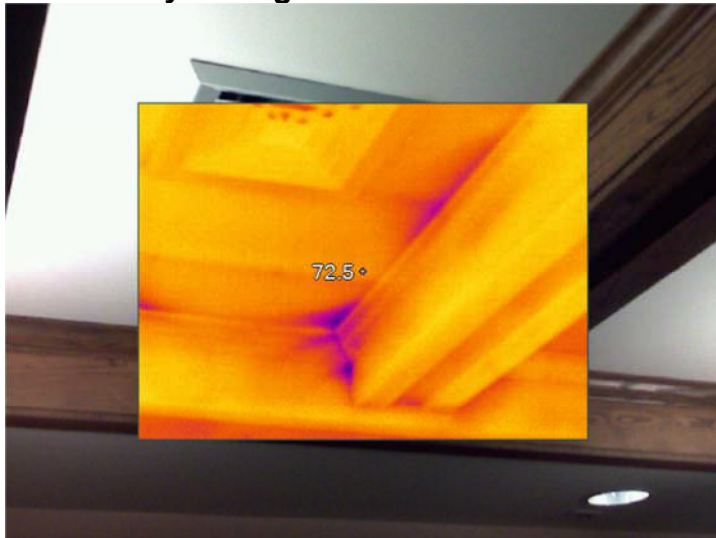
Main library ceiling near main entrance

Air leakage around coffered ceiling trim

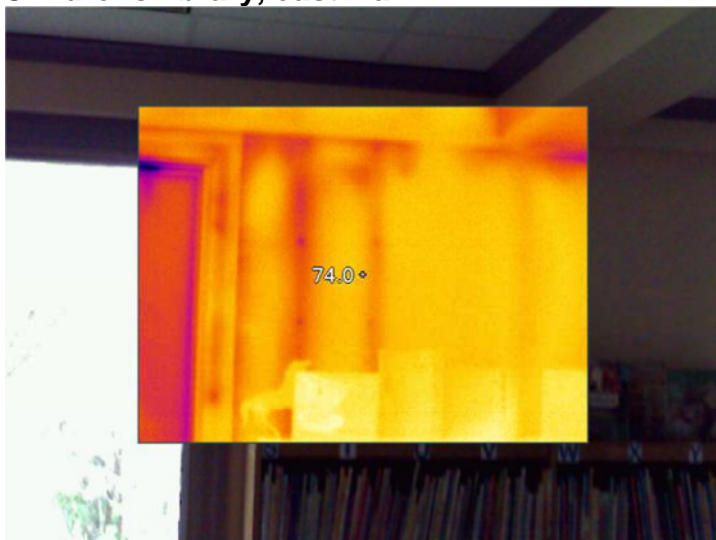
Childrens library, east wall

Poorly installed insulation allowing air circulation inside wall cavities
